# Your Best & Safest Choice

## Environmental hazards

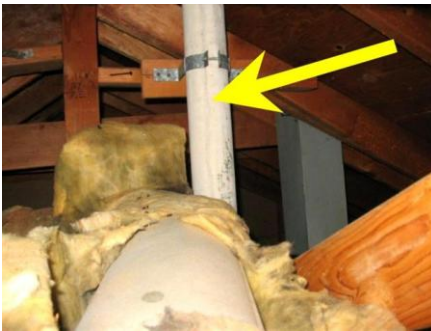
Figure 1. Possible asbestos insulation on furnace exhaust flue in attic.

Asbestos can also be found in some types of attic insulation and some types of ceiling acoustic tiles, as well as many other places depending on when the home was built. Another very common area where asbestos still exists in our homes is as insulation on exhaust flues on forced air furnaces (typically in the attic; see [Figure 1](#)) and water heaters (see [Figure 2](#)). Asbestos exhaust flue insulation, also called asbestos pipe wrap, is one of the more hazardous uses of asbestos because it is less stable than other forms of asbestos materials due to the heat from the exhaust flues. Generally it is safe to assume that insulated pipes contain some sort of asbestos pipe insulation material. Because asbestos pipe insulation is prone to deterioration, most authorities consider it a friable asbestos material and a health hazard.

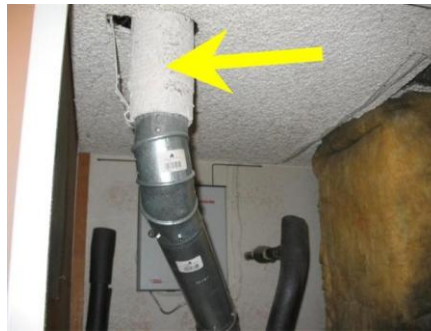
Figure 2. Possible asbestos insulation on water heater exhaust flue.
